The Return of the . . . Caprice Police Patrol Vehicle

TECHLINE news

GM TECH *Link*

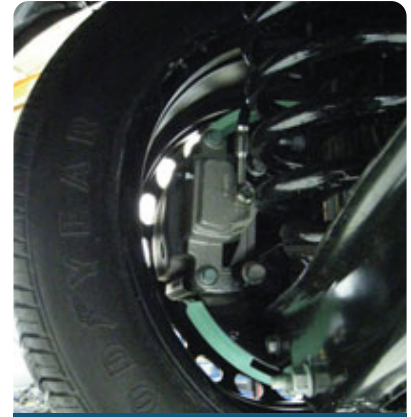
Rear wheel brake disc protection cover

TIP: Vehicles are shipped with protection covers on the brake discs of the rear wheels only. With the vehicle on a hoist, rotate the wheel while at the same time pulling the torn end of the cover away from the brake disc and wheel. Ensure that all material is removed and repeat for the other wheel.

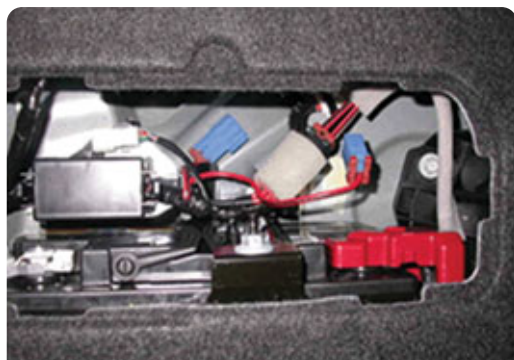
Primary battery in trunk with blue transit isolation connector

To ensure that the battery is delivered in the best possible condition, a blue transit isolation connector is located above the battery in the vehicle trunk. When the vehicle is shipped, it is disconnected, isolating circuits which contribute to parasitic battery drain. This connector should remain disconnected if the vehicle is stored for a period of time before delivery.

TIP: During the pre-delivery inspection, the transit isolation connector must be connected to enable operation of the radio, HVAC, instrument cluster, and central locking. Connect the two blue mating connectors until a click is heard. After connecting, lightly pull to confirm the connection and that the connector halves cannot be easily separated.

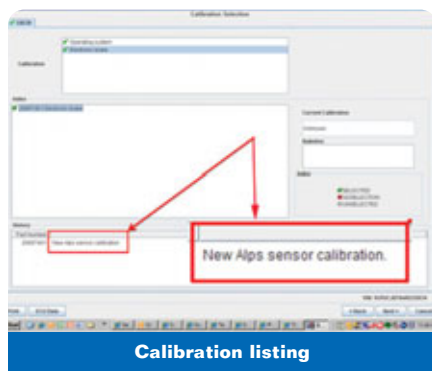
If a Steering Wheel Position Sensor (SWPS) has been replaced on a 2010 Escalade, Avalanche, Silverado, Suburban, Tahoe, Sierra, Yukon, Yukon Denali, Yukon XL, or Yukon Denali XL and current DTC C0455 or C0710 is set while turning the steering wheel, the incorrect SWPS may be installed.

For the 2010 models, there are 1st and 2nd design SWPS, depending on the EBCM calibrations. When replacing the SWPS, use the original part number removed to obtain the correct replacement part.

1. Using TIS2Web, check the EBCM calibrations. If the calibration listed shows "New Alps Sensor Calibration," the 2nd design SWPS should be used.
2. If the calibration does NOT show "New Alps Sensor Calibration," the 1st design SWPS should be used.
3. Use the following chart to help determine the correct part number.

All models (except 2500/3500 Silverado and Sierra)	1st Design 15886733
All 2500/3500 Silverado and Sierra	1st Design 25855607
All models	2nd Design 20910871 (TIS2Web will show "New Alps Sensor Calibration")

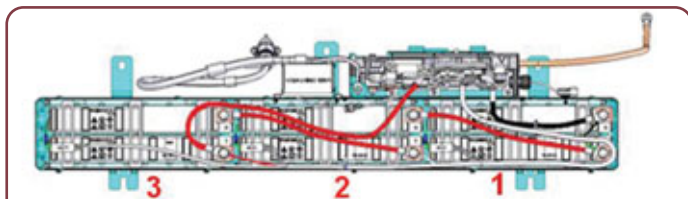
Hybrid battery pack:
1. Right battery 2. Center battery
3. Left battery

The red voltage sensor lead and the 36V positive cable are attached to the positive terminal of battery 3 (left).

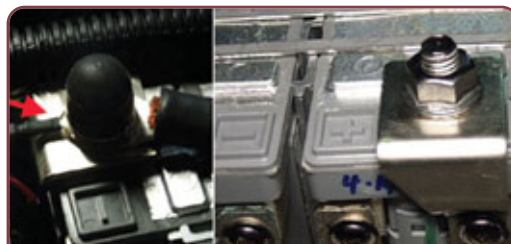
Battery DTCs P1A26, P1A22, P1A29, P1A30, etc. may be present after battery replacement.

Voltage sensor and cable are attached to the positive terminal (left) and the bus bar is located on the negative terminal (right)

Check the battery temperature sensor installation. The newer batteries have a larger cavity to accept the temperature sensors. The temperature sensors must be inserted into the cavity up to the heat shrink in order for them to be retained properly.

If DTCs P0AF8 or P0AFB are setting, check that the 200 amp fuse located on the negative battery cable is not cracked and that the composite nut is properly torqued and seated in the ring terminal. Also check the BECM and contactor connections.

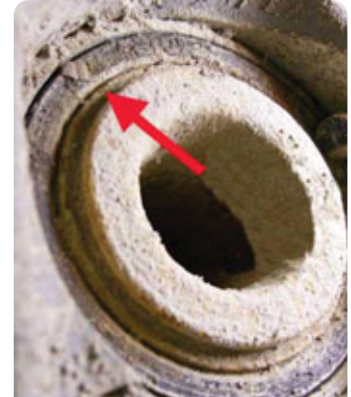
This condition may be caused by single or multiple pieces of ferrous metallic debris stuck to the wheel speed sensor magnetic encoder ring.

Typical debris on the magnetic encoder ring before cleaning

TIP: Most repairs can be performed without replacement of the bearing hub assembly or wheel speed sensor. Be careful not to damage the bearing outer seal when brushing or cleaning the magnetic encoder debris.

Do not use any type of magnetic tool to remove the debris from the bearing magnetic encoder. An external magnet can damage the encoder.

2. If debris is found, gently use a dry nylon soft bristle brush to remove the foreign debris from the magnetic encoder ring. If debris was removed, proceed to step 3.

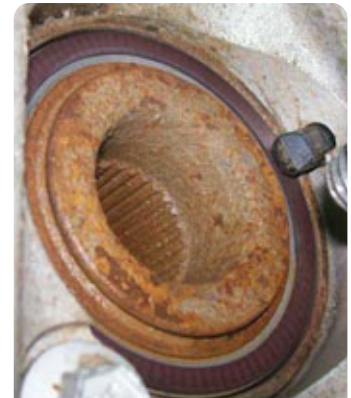
Magnetic encoder ring after cleaning
