The Return of the . . . Caprice Police Patrol Vehicle

TECHLINE news

GM TECH *Link*

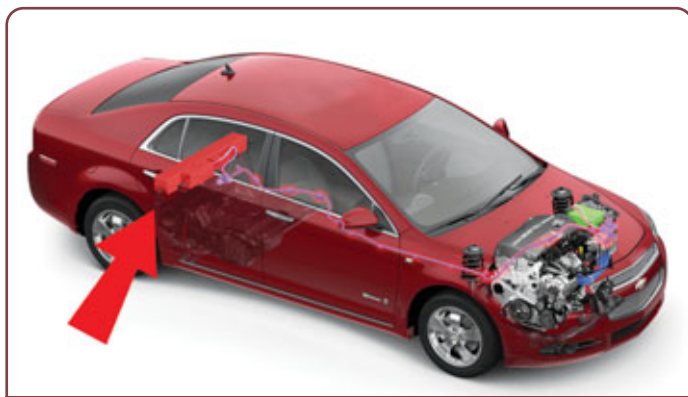
Hybrid battery pack behind the rear seat.

When replacing the batteries and reinstalling the cables or voltage sensors on the 2008-10 Malibu Hybrid and 2007-09 AURA Hybrid and VUE Hybrid, it's important to note the polarity and positive or negative nodes.

After servicing the battery pack on these models equipped with the Belt Alternator System (BAS) Hybrid system, a low battery voltage or a no charge condition may occur with or without the following DTCs:

If DTCs P0AF8 or P0AFB are setting, check that the 200 amp fuse located on the negative battery cable is not cracked and that the composite nut is properly torqued and seated in the ring terminal. Also check the BECM and contactor connections.

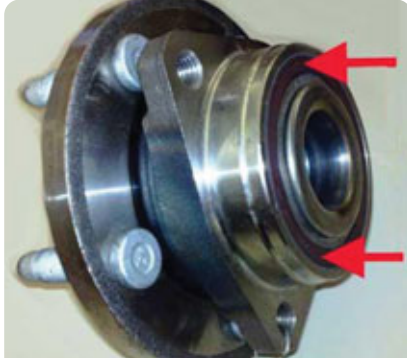
This condition may be caused by single or multiple pieces of ferrous metallic debris stuck to the wheel speed sensor magnetic encoder ring.

Instead of a traditional mechanical-type tooth tone wheel, some new model vehicles use a wheel speed sensor tone wheel made of a magnetized nitrile rubber ring, typically brown in color. This magnetic encoder ring is now part of the in-board bearing hub assembly.

New bearing design with magnetized nitrile rubber ring

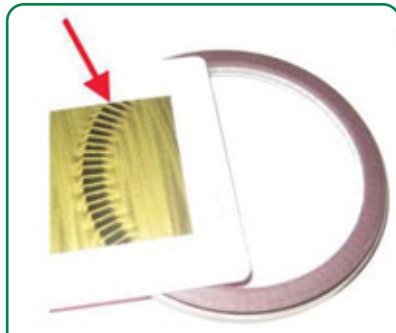
Magnetic encoder ring with North and South poles shown

with symptom bytes 18, 5A, 0F can be repaired by removing or cleaning any accumulated debris on the magnetic encoder ring, located on the inboard side of the bearing hub.

TIP: Most repairs can be performed without replacement of the bearing hub assembly or wheel speed sensor. Be careful not to damage the bearing outer seal when brushing or cleaning the magnetic encoder debris.

Do not use any type of magnetic tool to remove the debris from the bearing magnetic encoder. An external magnet can damage the encoder.

2. If debris is found, gently use a dry nylon soft bristle brush to remove the foreign debris from the magnetic encoder ring. If debris was removed, proceed to step 3.

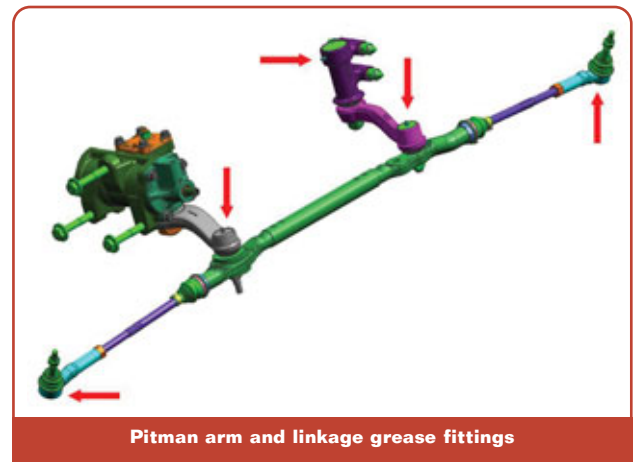
For example, there are five grease fittings that should not be overlooked on the pit-

man arm and linkage of the HD trucks and vans. Grease should be applied until it's observed that the grease boots are expanding.

As detailed in the Owner Manual — which can be found in the Service Information for each model — under Scheduled Maintenance/Every Engine Oil Change, vehicles used in severe commercial operating conditions require lubrication on a regular basis every 3,000 miles/5,000 km or more.
